# Investigating strain age cracking in precipitate hardening nickel-based alloys using in-situ diffraction and tomography

## THE INDUSTRIAL CHALLENGE

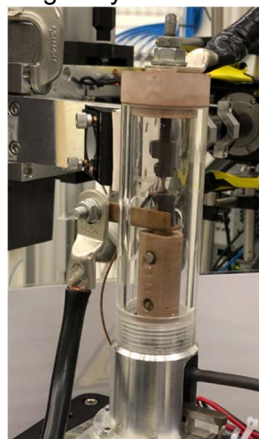
**Figure.** Compact load frame used to for the in-situ loading and heating 3DXRD, SAXS and tomography experiments. Joule heating are utilized for heating the sample.

Experiments designed to understand the strain age cracking mechanisms were done at the Swedish materials science beamline, P21.2, at the Petra III synchrotron, Germany. Small Angle X-ray Scattering (SAXS), 3D X-ray Diffraction (3DXRD), and tomography were utilized in the experiments during the in-situ heating and loading of the sample using a for the project developed compact load frame. This setup covers length scales from the nm-range to the mm-range. From the results, it is possible to study the misfit strains that occur during the
